Manhole Inspection Summary

Manhole # S13MM_015MH

Insp Date: **6/24/09 3:12 PM**

Location Address: **ELGIN AVE**

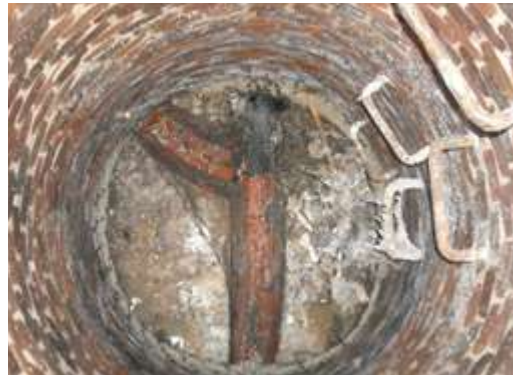
Top View

LOCATED IN GRASS ADJACENT TO
NODE 021

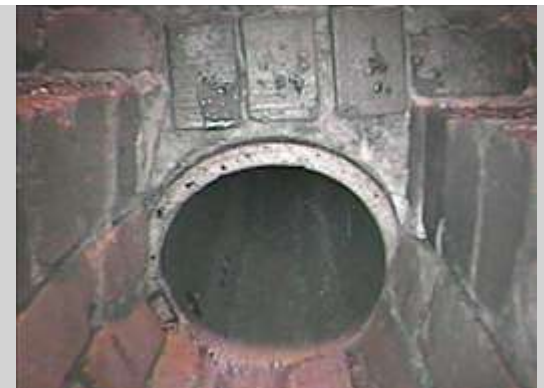
6 O'Clock Inflow

8 in. Circular Gravity Sewer
Pipe In @ 6 O'Clock

Pipe Height: **8.4** (in.) Rod and Bar (Angled)
Pipe Material: **Clay** ☐ Pipe Lined
Invert Depth: **10.94** (ft.) Flow Characteristics: **Fast**
Deposits: ☒ None ☐ Mud ☐ Sludge ☐ Debris ☐ Grease
Silt Depth: (in.) Deposits Extent:
Infiltration: **None** Pipe Seal Cond: **Sound**
